HYPOGEAN ARCHAEOLOGY

Research and Documentation of Underground Structures

Italian Cadastre of Artificial Cavities

BAR International Series 1599

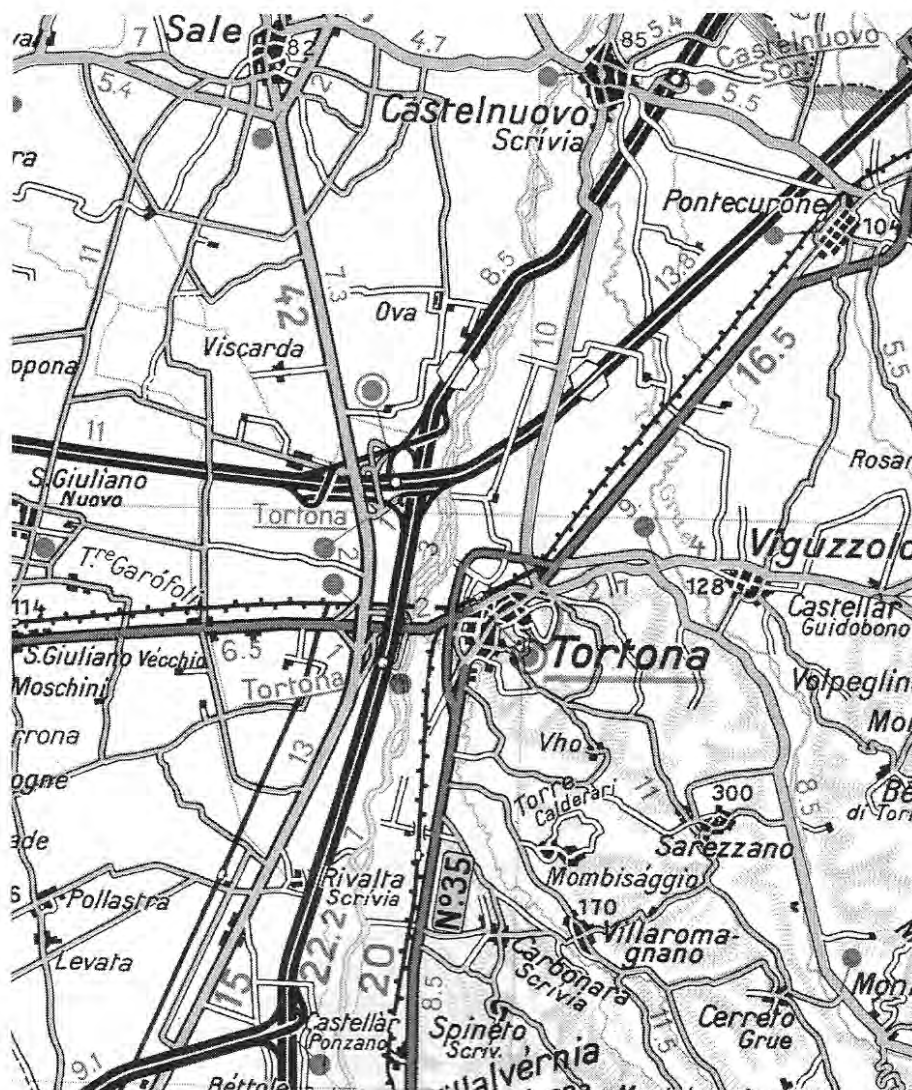
Fig. III. 6. Geographic framework: Tortona and Fort San Vittorio (Touring Club Italiano 2002 a, table 22).

The construction of Fort San Vittorio began in 1774 on the hill above Tortona (fig. III.6). the building was built on a previous fortification with mediaeval layout. The western crownworks were retained and restructured accordingly. The rear Hornwork parapet is raised and defiles Fort San Vittorio's western front. Of an irregular rectangular shape, it has angle ramparts, ditches and counterscarp works. Despite its small dimensions, the Fort is well-structured and its batteries are positioned on multiple levels. Occupied by French troops following the War in the Alps, it was besieged by Austro-Russian troops in 1799 (Comoli Mandracci, Marotta 1995). It was demolished a few years later. The current park layout to some extent preserves structures covered by soil and debris, to be restored at a later date.

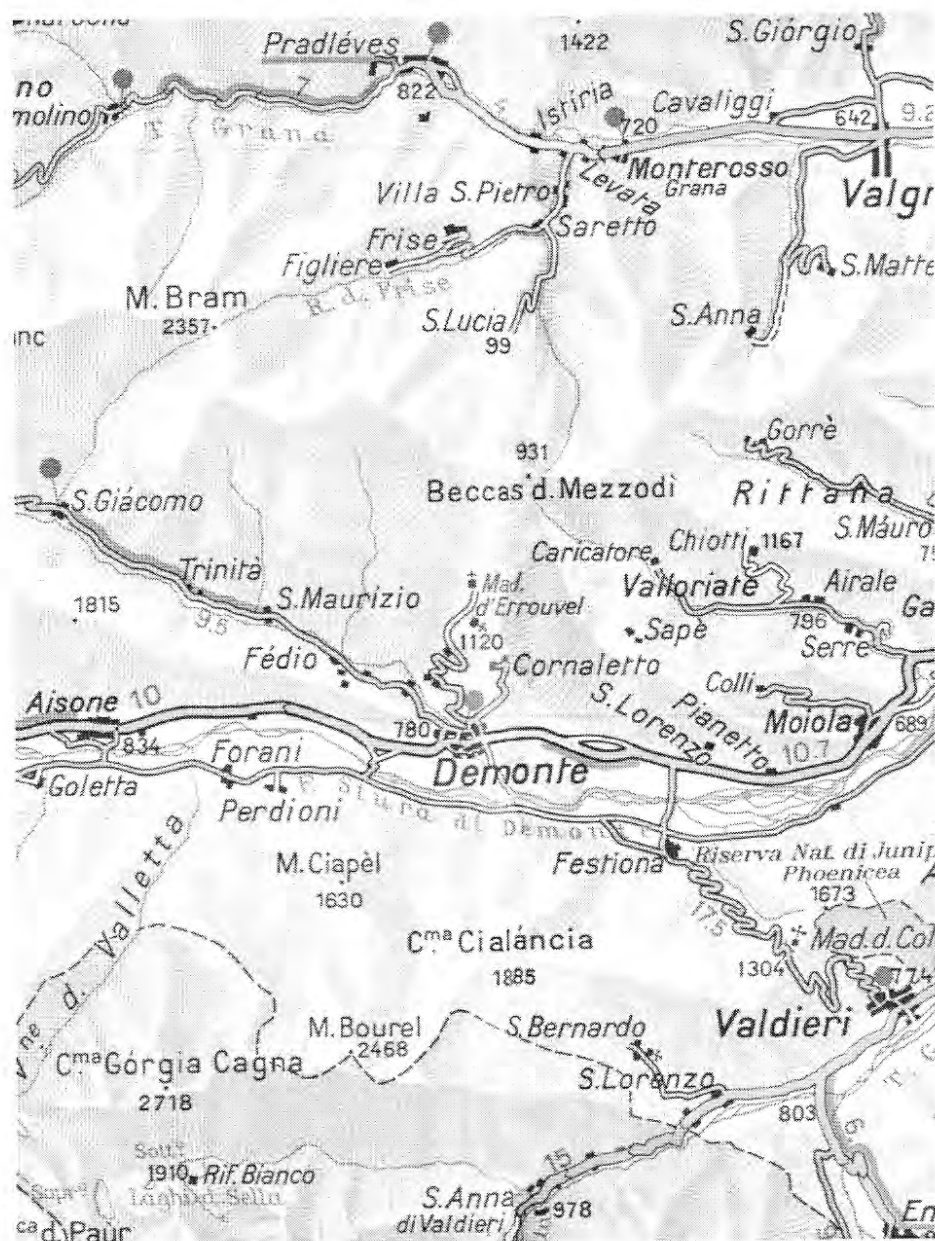
Fig. III.7. Geographic framework: Valle Stura and Fort Demonte (Touring Club Italiano 2002 a, table 27).

Fort Demonte once blocked Valle Stura and was built on the site of the old Consolata Fort, following its attempted demolition on the part of French troops in 1744 (fig. III.7). In 1754 the construction plants, utilised for more than ten years, were supervised by Bernardino Pinto. The fort was built on multiple storeys so the enemy could be attacked with plunging fire. It was disarmed and mined following Napoleonic invasion. Erroneously regarded as a simple pile of ruins, the fort's core remained intact, carved as it was, directly into the rock. In fact, only the masonry structures were almost completely demolished and the Fort was at any rate, recoverable as a historic monument.

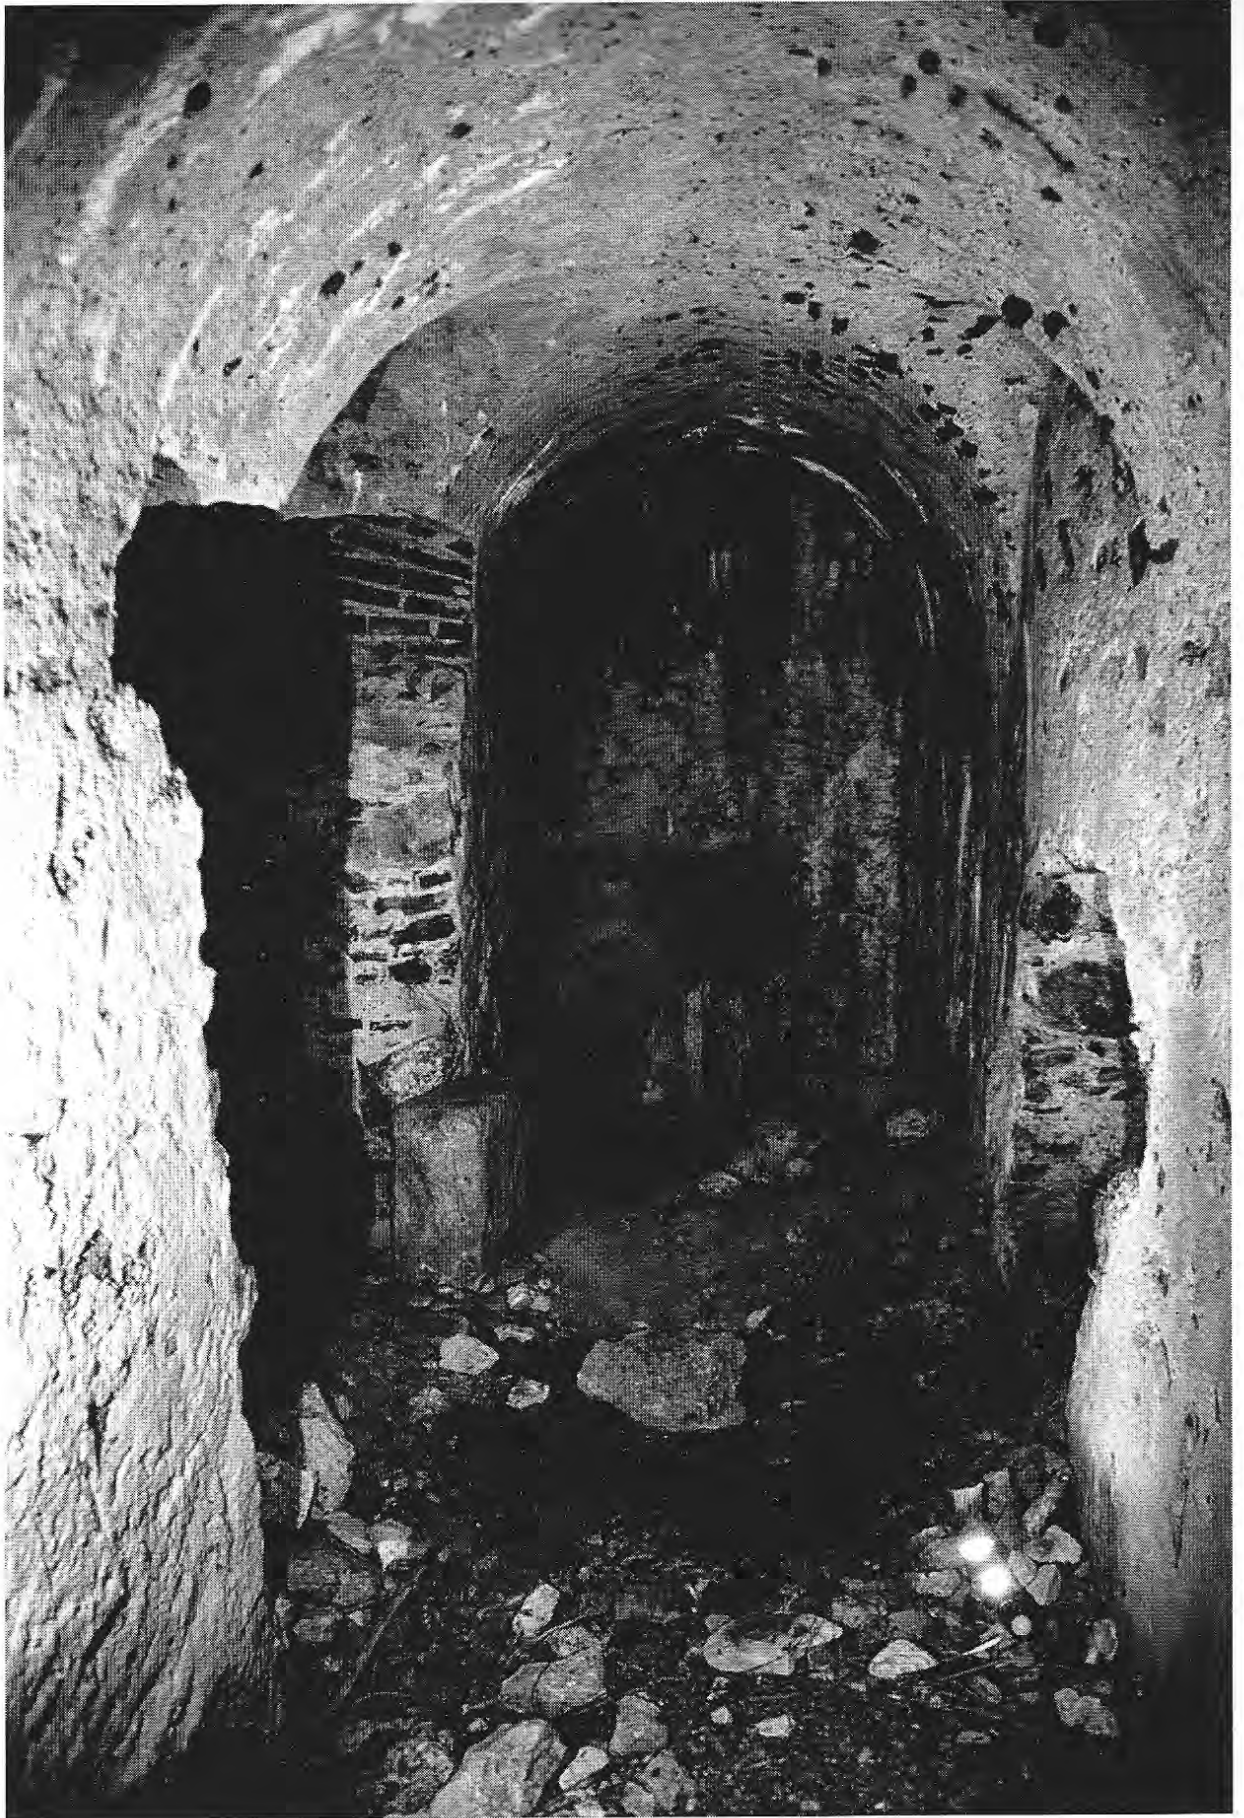
Warnings: structural collapse of the current entrance

Fig. III.15. a. *Counterscarp Gallery of the Bastion of Saint Ignatius (CA 00001 PI CN)* (photo G. Padovan).

Notes: an adequate dig would completely uncover the structure. The recovery of the entire ditch is also recommended.

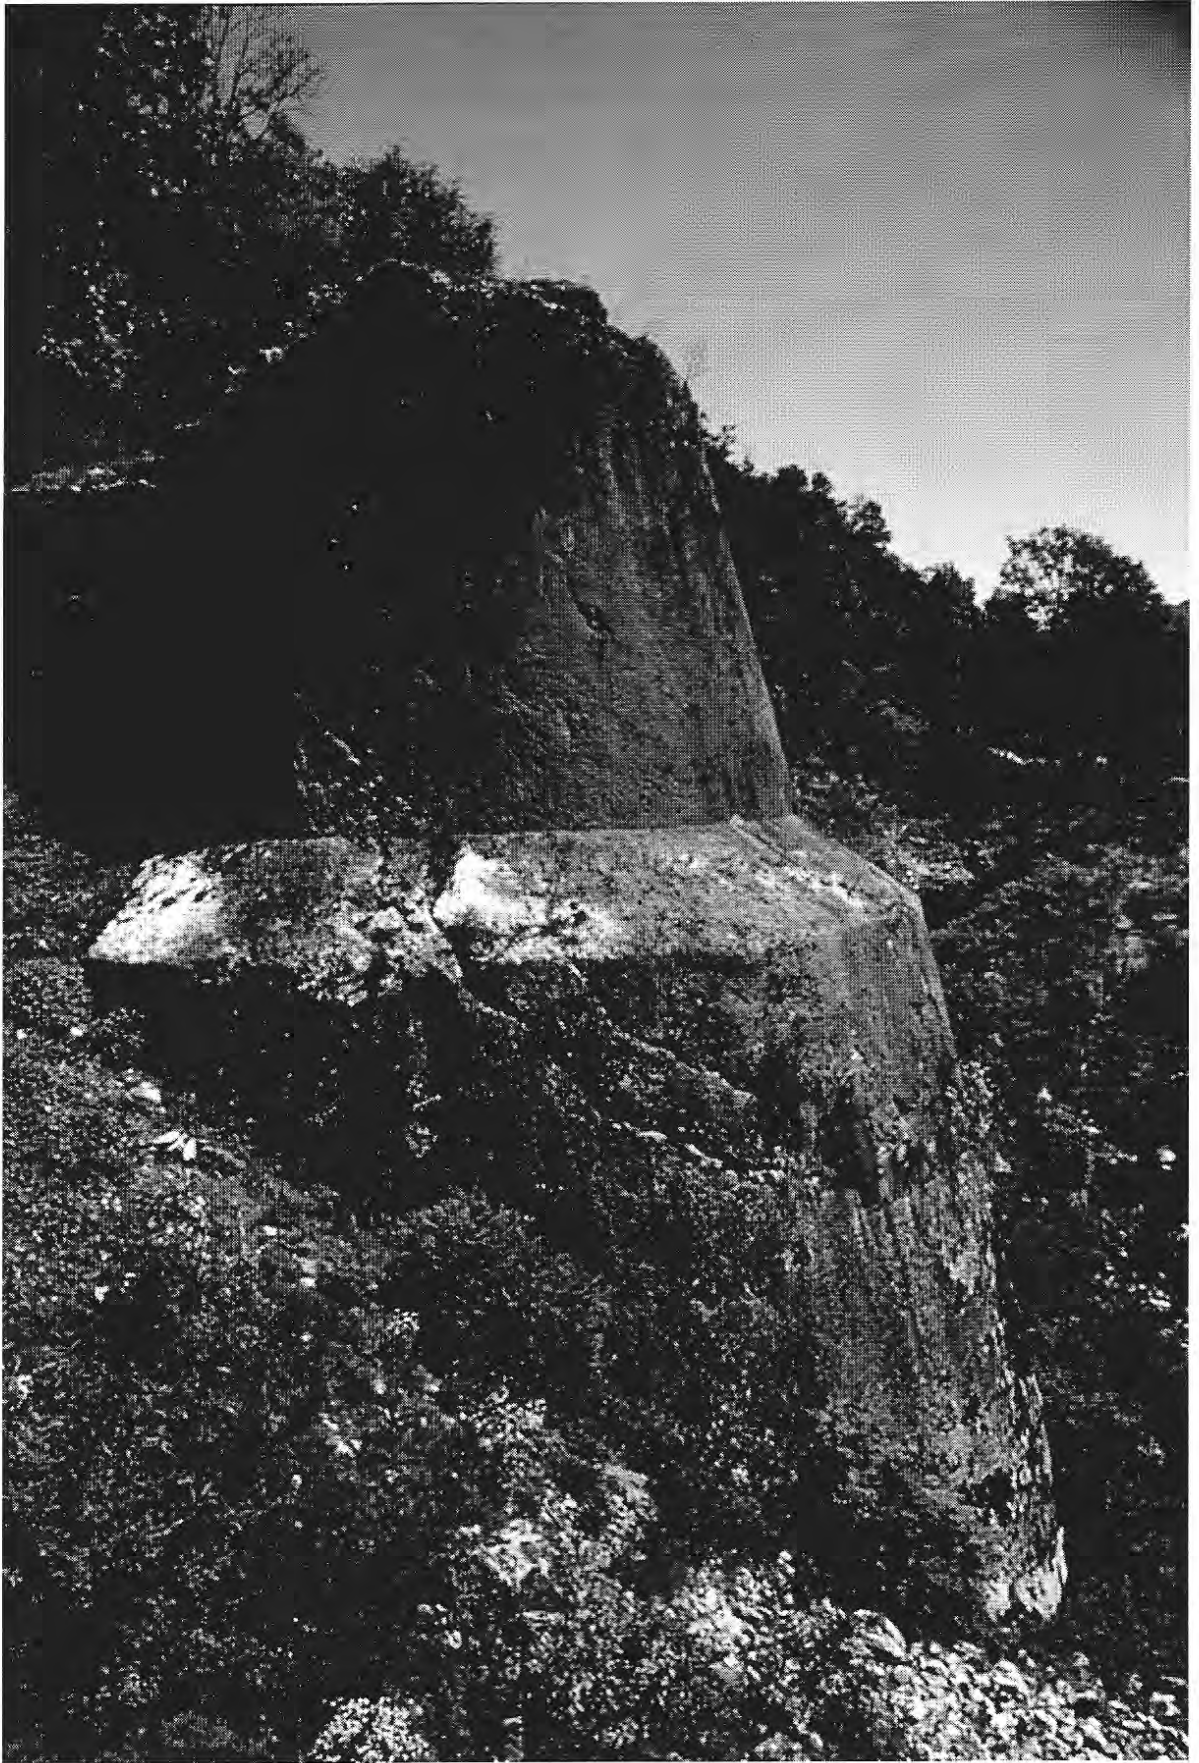
Fig. III.18.a. "Tenaglione verso Stura" cut into the limestone, situated east of the Bastion of Saint Ignatius (photo G. Padovan).

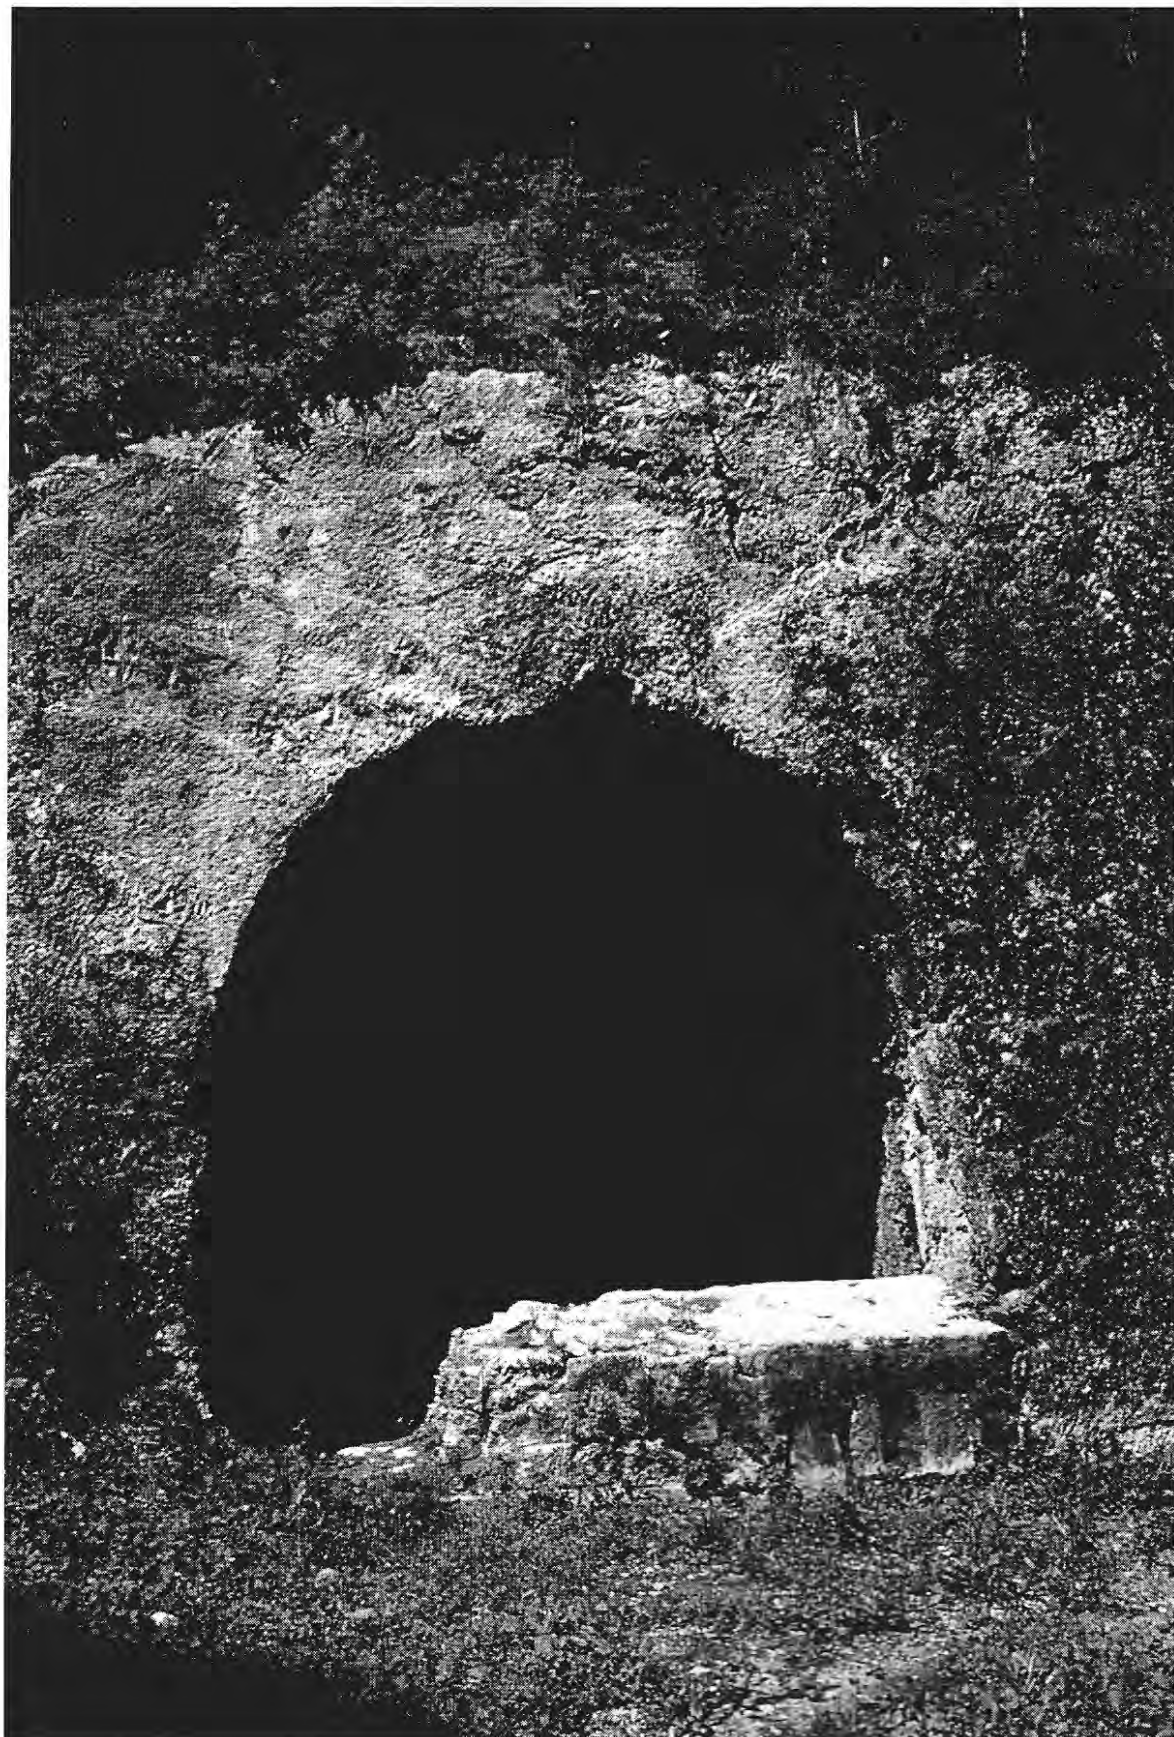
Fig. III.22.a. *Primary Shelter on the Hornwork Counterscarp (CA 00005 PI CN) (photo G. Padovan).*

Description: two stone-carved rooms are to be found in the counterscarp of the cyclopean ditch protecting the Hornwork, which is carved into the rock. The first, known as the Primary Shelter, is situated next to the stairwell which leads from the counterscarp to the bottom of the ditch. The large, trapezoidal room (4.79 x 7.32 x 6.44 x 7.47 m) is easily accessed and contains no debris. Inside there are currently tables and chairs as well as a fireplace in the inside left corner. At the entrance, the semi-circular vaulted arch measures 5.16 m whereas it is squashed towards the base. It is 5.95 m high. The entrance is protected by a low but thick masonry wall, the upper part of which gently slopes outwards. It could easily be the original boundary rather than a later structure built during the restoration of the covered area, despite the traces of fairly recent hydraulic mortar, thought to have been used during maintenance works. The rock floor, which gently slopes inwards, cannot be dated due to the fine layer of detritus and hay, which cover it; the exposed walls show clear evidence of excavation tools. The bottom part has two recesses (of 27 x 22 cm and 30 x 14 cm), believed to have been used for the placement of wooden supports. There are non recesses for hinges or bolts, therefore the does not appear to have had a door closure. In the event of siege, the room would certainly not have been considered safe.

Notes: the large ditch could easily be cleared of debris and restored to its original, imposing form, with little effort or expense.
